MPIC/R-1261/64 June 1964

## PHOTOGRAPHIC INTERPRETATION REPORT

## BOMB DAMAGE ASSESSMENT KHANG KHAI MILITARY COMPLEX AND BAN BAN MILITARY CAMP, LAOS .

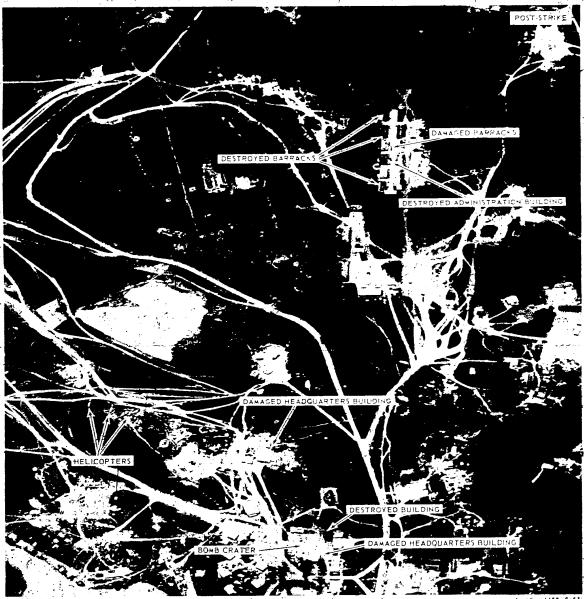
NPIC R-1261 64

Khang Khai Military Complex was reportedly attacked by one T-28-type aircraft on 11 June 1964; the amount of expended ordnance was, reportedly, one 250-pound bomb and 4 rockets, size unknown. Two large administration-type buildings in the military headquarters area were severely damaged, one by a blast from a bomb whose crater is rubble filled and one by fire, to the extent that they are probably unusable. In the military parracks area one administration-type building and 3 barracks were completely destroyed by fire, probably caused by rocket hits. One additional barracks has sustained some roof damage, but is probably still usable. He additional bomb craters have been identified, and there is no other apparent damage to other facilities or equipment within the complex. See attachment 2.

Buildin			, 0	•
1	Barracks		100	2470 ENE
, 2	Barracks V		100	2350 . ENE
*5	Barrachs, 🤏		25	2250 EILE
4.7.	Addin		100	2150 ENE
5	, Barracks		100	1900 ENE
6.5	Admin	$80 \times 50 \text{ ft}$	50	625 Nii 1
**7	Admin	55 x 50 .1t	_35	750est

Observed roof damage.Observed blast damage.

KHANG KHALMILITARY COMPLEX LAOS
